# Gamma Count Rate Survey in Pines, Indiana

Conducted October 10 - 15, 2009

# PINES (People in Need of Environmental Safety)

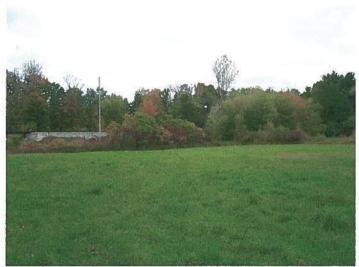
624 Railroad Avenue, looking east

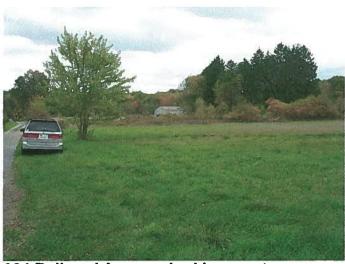
624 Railroad Avenue, looking west

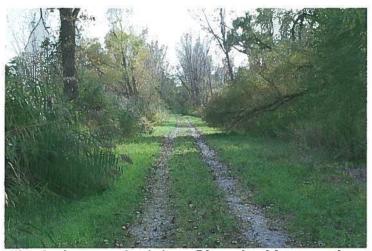
Illinois Avenue from Railroad Avenue to Johns Avenue 4500 – 12,000 counts per minute (cpm) lower count rates near Johns Avenue higher count rates where glittering black material was present

Minois Avenue At Johns Place looking south

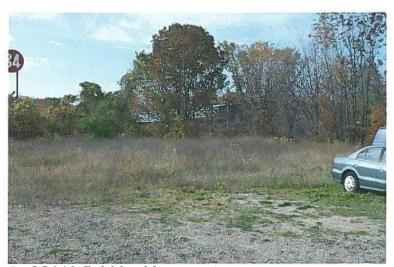
- \*\* Parking lot on "slag" type material 8000 – 9000 counts per minute (cpm)
- \*\* Weedy field to west of parking lot 7000 8000 cpm
- \*\* Dumping area to north of parking lot 7000 8000 cpm
- \*\* Lowland area to north of dumping area and north of parking lot 5000 6000 cpm

At SS018 field looking west

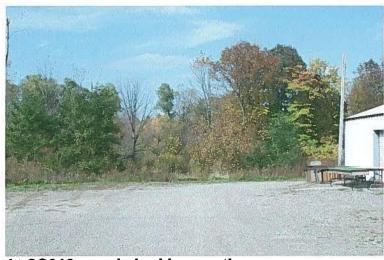
At SS018 woods looking north

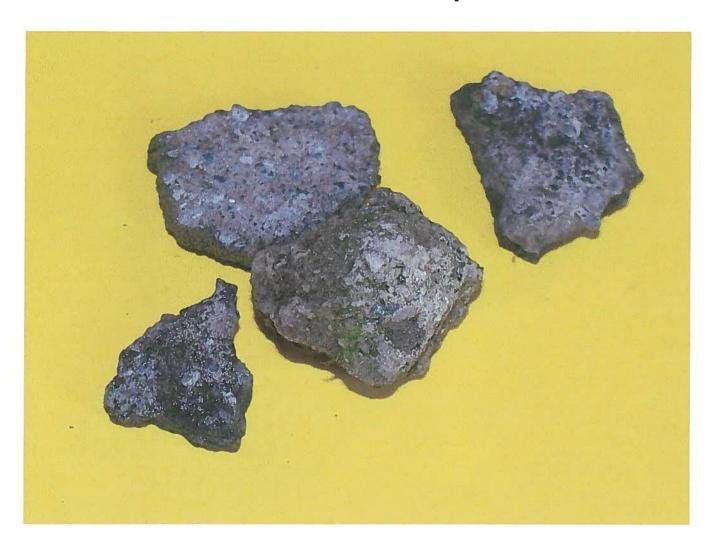
# **Stones from Mosque**

One less elevated count rate area was at Exemption 6 where material looking like stone, or perhaps slag, on the east side of the parking lot had a count rate of about 7500 – 8000 cpm.

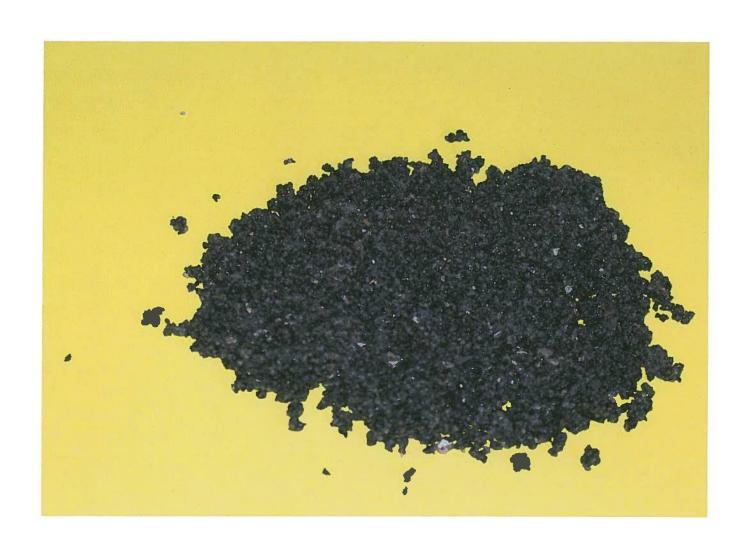
## Black, Glittery Material

In almost every case, excess count rates were associated with a black, glittering material. PINES surveyors called this material flyash. The survey leader was more familiar with material of this appearance being called sand blasting grit. The most elevated gamma-ray count rates were all associated with roadways and the berms adjacent to them.

Where readings were elevated, the area was usually covered with a black, glittery material with the appearance of finely ground obsidian. Surveyors called this material flyash. The health physicist operating the meter had seen similar material used for sandblasting.

Determination be made as to the component giving elevated gamma-ray count rates (e.g., black glittery material?).

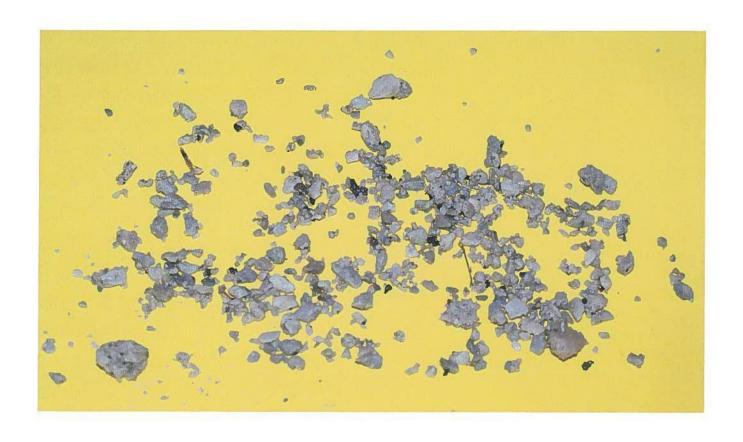
## **Calumet Bike Trail Stone**

"Limestone" fill on trail

2 minute count with probe tip on contact with the ground 6103 counts/2 minutes = 3052 cpm
